# Manhole Inspection Summary

Manhole # S13CC\_034MH

Insp Date: **2/25/08 2:26 PM**

**Location** Address: **2838 WINCHESTER ST** Cross Street: **POPLAR GROVE ST**

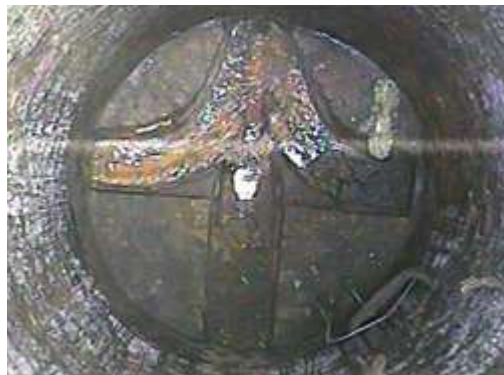
Top View

Condition: ☐ Sound ☐ Cracked ☐ Root Intrusion ☐ Deteriorated ☐ Leaks ☒ **Debris**

**Steps** Count: **4** Missing: **3** ☐ Corroded

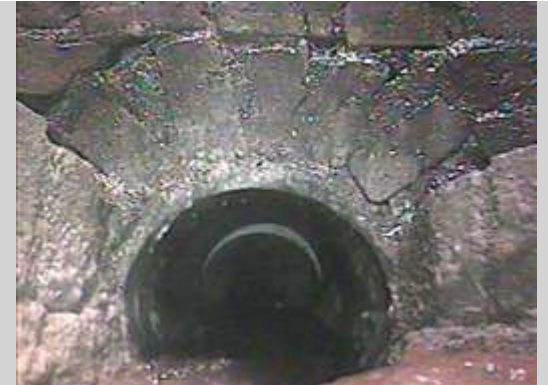
12 O'Clock Outflow

8 in. Circular Gravity Sewer  
Pipe Out @ 12 O'Clock

Pipe Height: (in.) Direct  
Pipe Material: **Clay** ☐ Pipe Lined  
Invert Depth: **8.40** (ft.) Flow Characteristics: **Fast**  
Deposits: ☒ None ☐ Mud ☐ Sludge ☐ **Debris** ☐ Grease  
Silt Depth: (in.) Deposits Extent:  
Infiltration: **None** Pipe Seal Cond: **Sound**

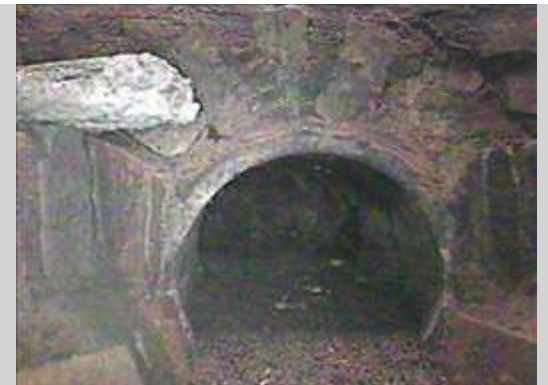
3 O'Clock Inflow

8 in. Circular Gravity Sewer  
Pipe In @ 3 O'Clock

Pipe Height: (in.) Direct  
Pipe Material: **Clay** ☐ Pipe Lined  
Invert Depth: **8.15** (ft.) Flow Characteristics: **None**  
Deposits: ☐ None ☐ Mud ☐ Sludge ☒ **Debris** ☐ Grease  
Silt Depth: **2** (in.) Deposits Extent: **Light**  
Infiltration: **None** Pipe Seal Cond: **Sound**

Connects To: **Stub connection / abandoned**

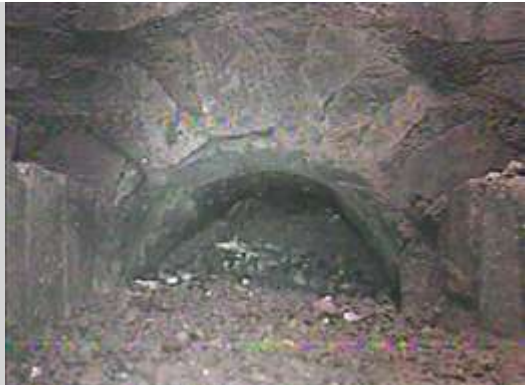
6 O'Clock Inflow

8 in. Circular Gravity Sewer

Pipe In @ 6 O'Clock

Deposits: ☐ None ☐ Mud ☐ Sludge ☒ **Debris** ☐ Grease

Silt Depth: **8** (in.) Deposits Extent: **Heavy**

Connects To: **Stub connection / abandoned**

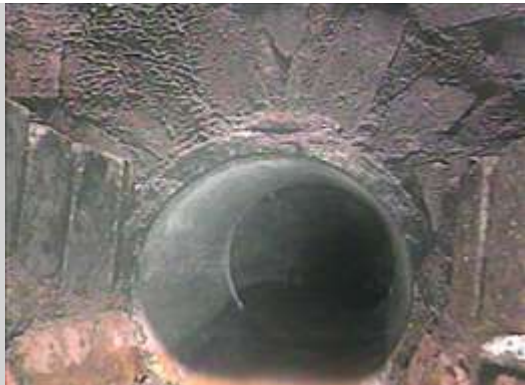
9 O'Clock Inflow

8 in. Circular Gravity Sewer

Pipe In @ 9 O'Clock

Deposits: ☒ **None** ☐ Mud ☐ Sludge ☐ Debris ☐ Grease
